NASA TN D-7215

**SOME EFFECTS OF GROOVED RUNWAY
CONFIGURATIONS ON AIRCRAFT TIRE
BRAKING TRACTION UNDER
FLOODED RUNWAY CONDITIONS**

by Thomas A. Byrdsong and Thomas J. Yager

Langley Research Center

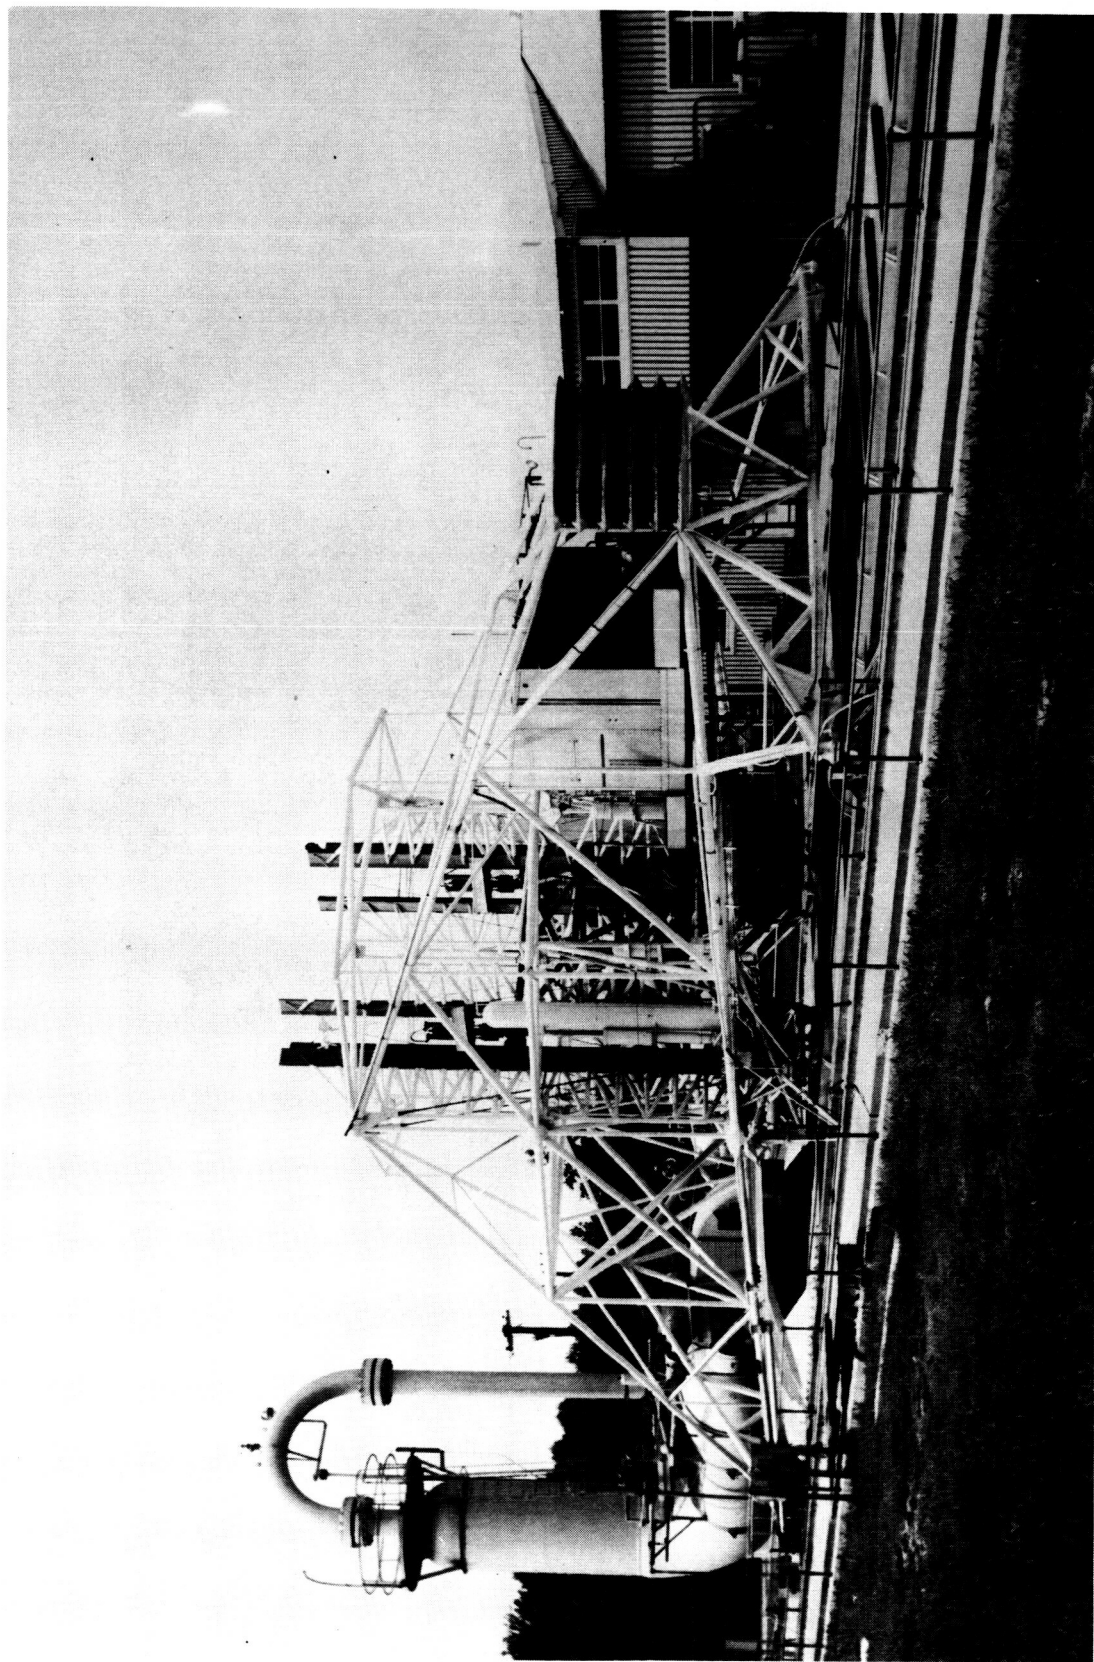
L-69-5860

Figure 1.- Main test carriage at the Langley aircraft landing loads and traction facility.

The investigation was performed at the Langley aircraft landing loads and traction facility and utilized the main test carriage shown in figure 1. A description of this facility and its operation is given in reference 8. The tire, wheel, and brake assembly (shown in fig. 2) were mounted on a dynamometer similar to that described in reference 8, which was instrumented to measure the various axle loadings. The dynamometer, in turn, was attached to a drop test fixture which, during a test, was positioned to allow the tire to roll on the test surfaces under a predetermined vertical load simulating an airplane rollout

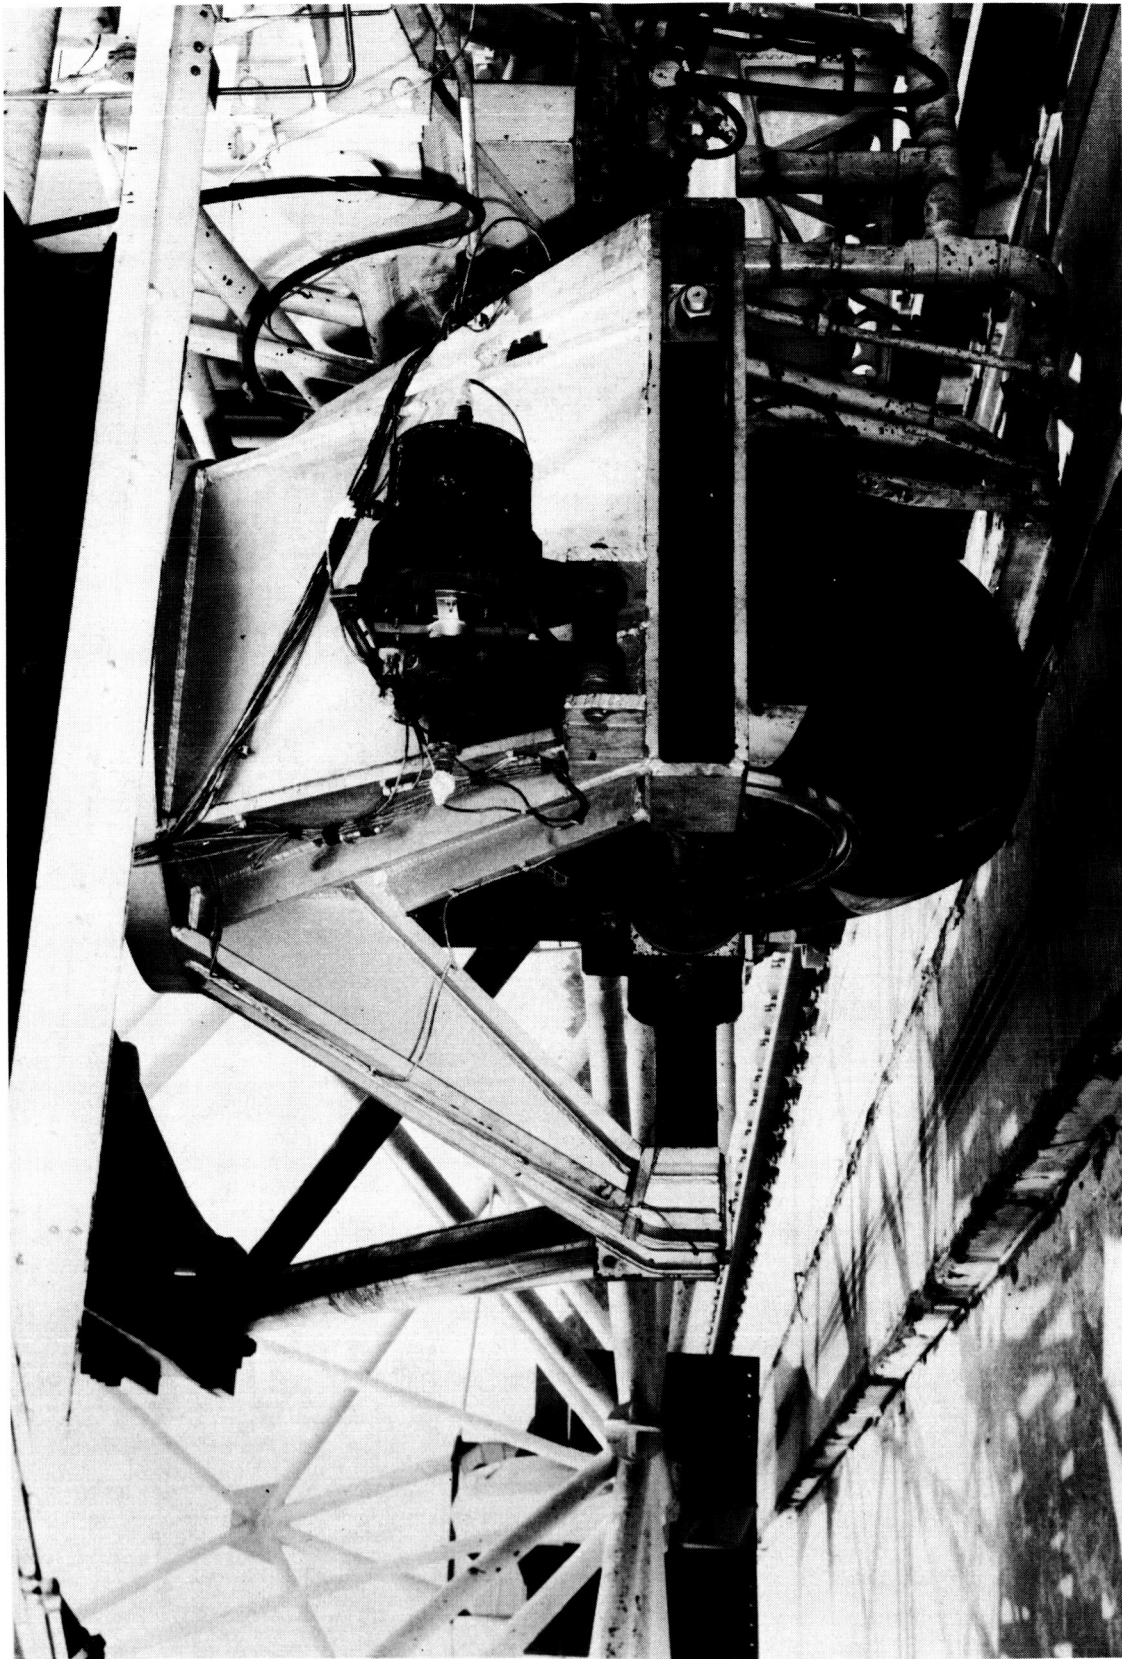
L-69-5862

Figure 2.- Main test carriage dynamometer with tire, wheel, and brake assembly.

Vertical and drag loads and brake torque applied to the test wheel were measured by the dynamometer load beams, and a dc generator indicated the instantaneous wheel angular velocity. The outputs from the load cells and the generator, together with signals which described the carriage ground speed, were transmitted to an oscillograph on board the carriage.

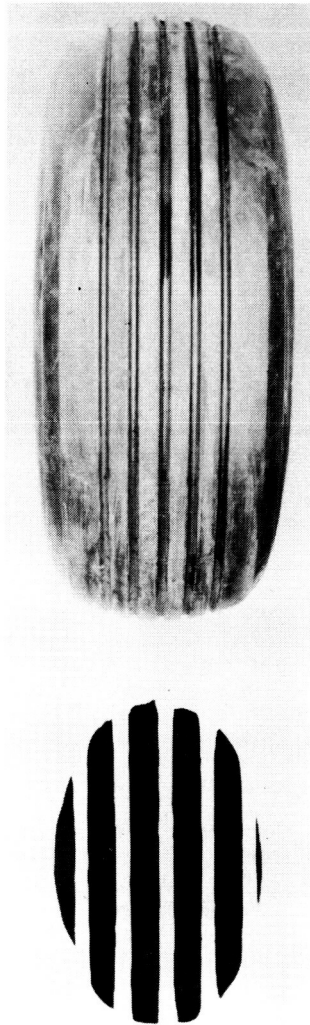
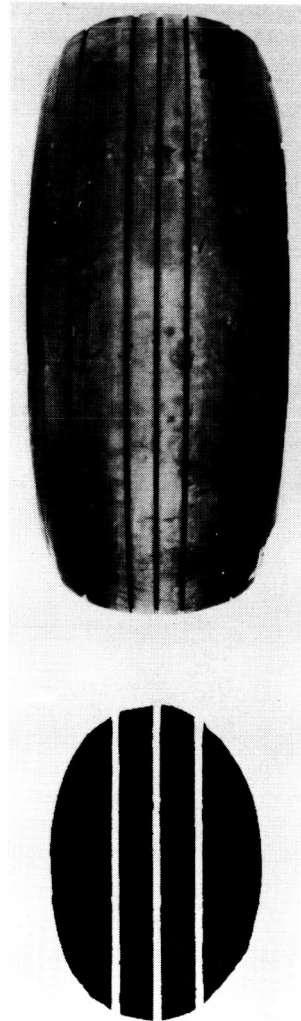
L-73-297

Figure 3.- Photographs of test tires and footprint under a vertical loading of 66.7 kN (15 000 lb) and inflation pressure of 117 N/cm² (170 lb/in²).

The tires of the investigation were size 49×17 , 26-ply rating, type VII, aircraft tires currently used on several different commercial and military jet transports. Photographs of the test tires are presented in figure 3 together with corresponding footprints obtained under a vertical load of 66.7 kN (15 000 lb) and an inflation pressure of 117 N/cm^2 (170 lb/in²). The relatively low vertical loading was selected for these tests to assure wheel lockups under all test conditions with the torque-limited brake used in this investigation. Both test tires were five-groove retread tires; however, as shown in figure 3, only the three middle tread grooves of tire B were in contact with the runway surface under the test loading conditions. The tread groove depths of both tires were nearly identical, but the tread grooves of tire A were much wider than those of tire B. The tread groove area represented approximately 33 percent and 13 percent of the total tire footprint area for tires A and B, respectively. In a companion study with four different tires of this size (see ref. 7), tire A exhibited the greatest susceptibility to chevron cutting tread damage and tire B the least damage during touchdown on grooved surfaces.

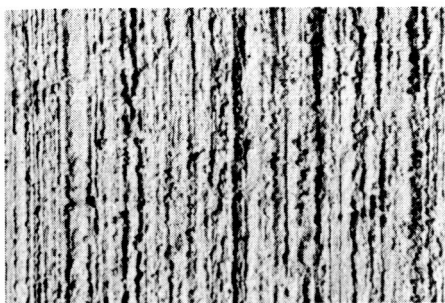
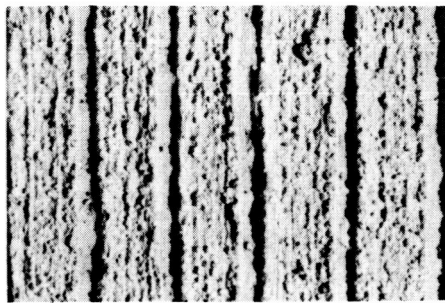
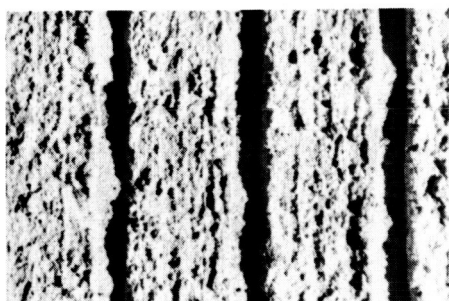
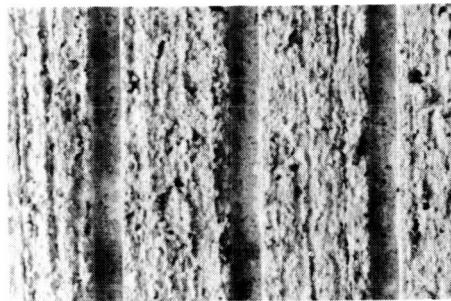
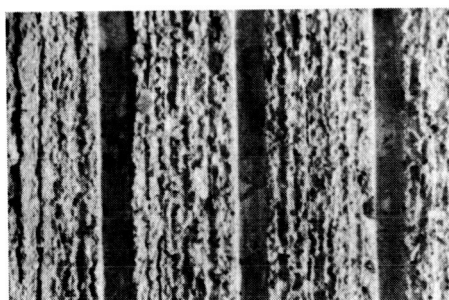
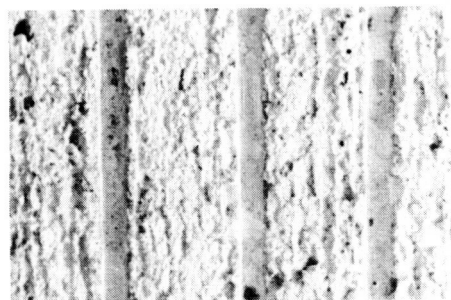
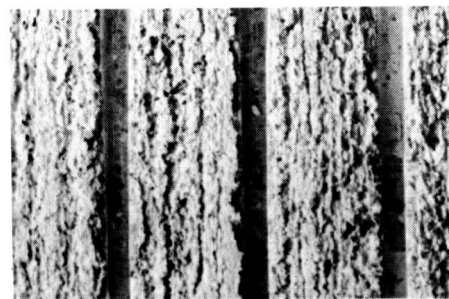
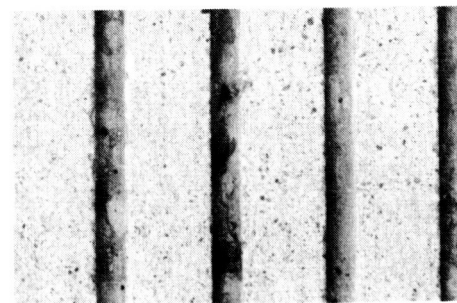
L-73-298

Figure 4.- Photographs of test runway surfaces.

the grooves. It should be pointed out that during the course of the sawed grooving operation, the lands of large areas of surface 6 were inadvertently ground by the grooving apparatus which essentially removed the striations, and left a polished surface between grooves. The photographs of figure 4 illustrate the texture and groove configuration of each test section but do not depict an area of surface 6 with polished lands. The figure shows that the grooves obtained from the combing technique, surfaces 2 and 3, are less uniform in width and depth than those obtained from the sawing technique, because, unlike the powered saw blade, the hand-operated rake tends to ride over the random aggregate in the concrete mix.

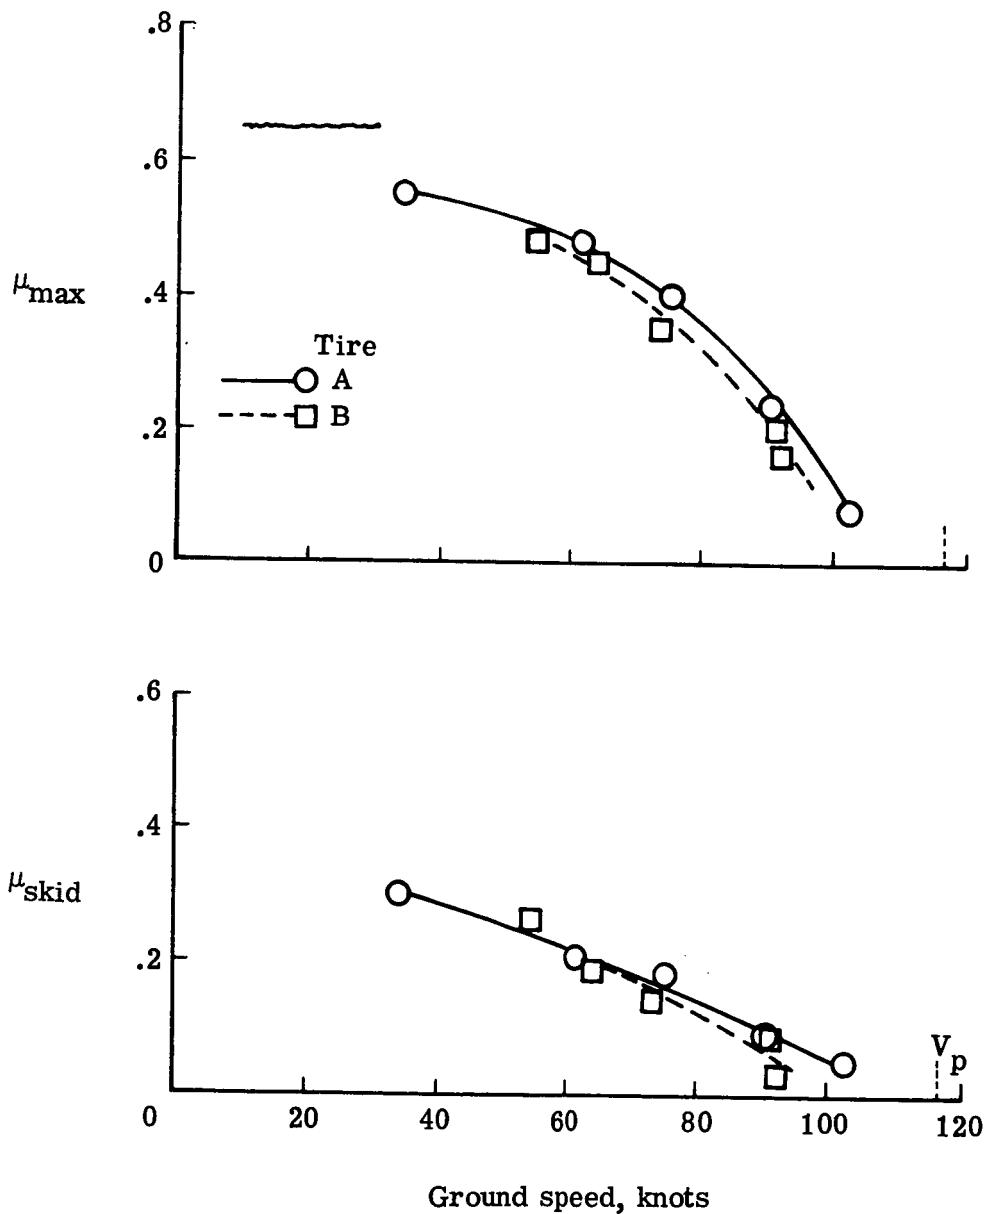
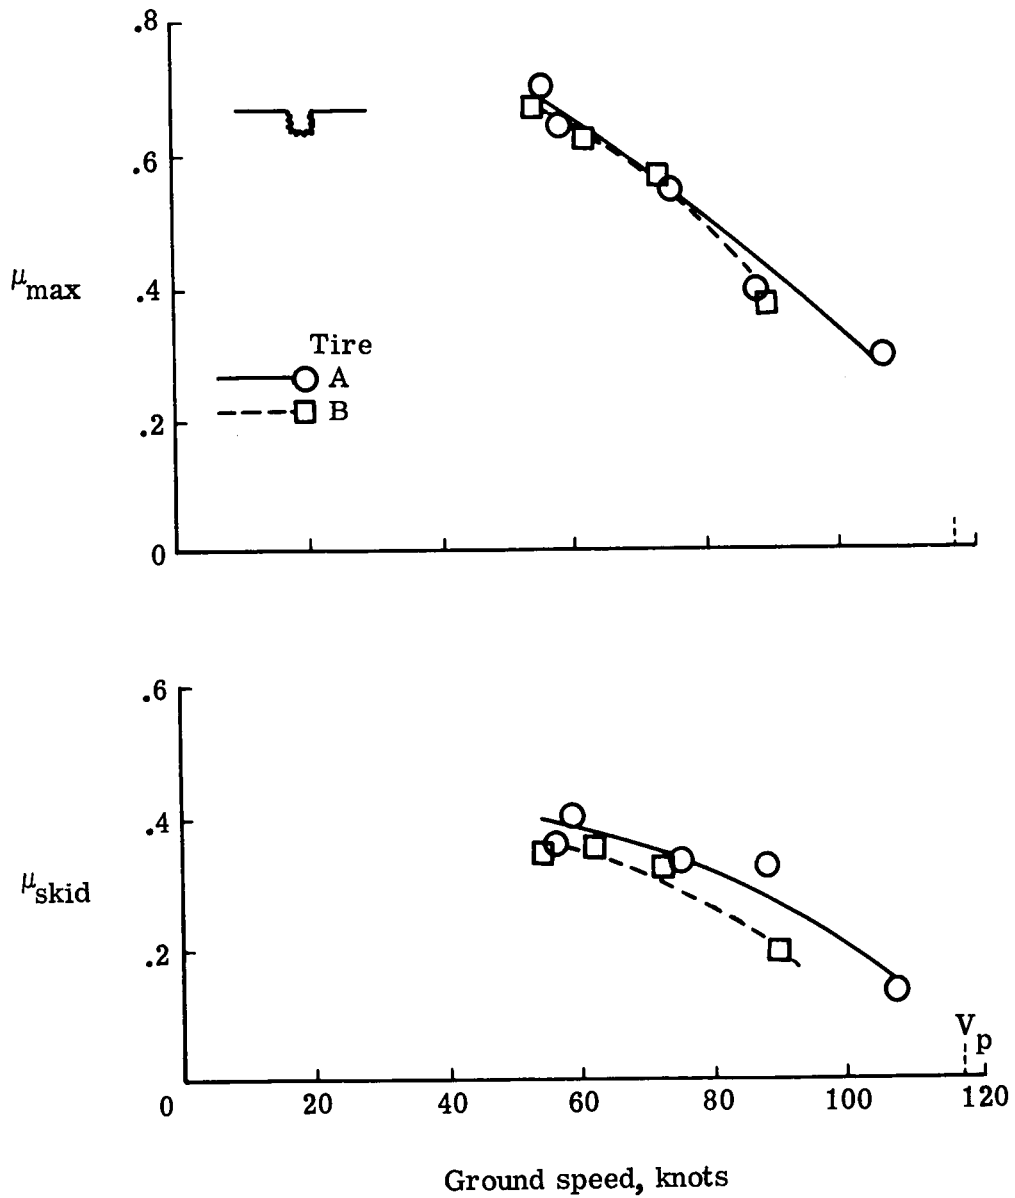
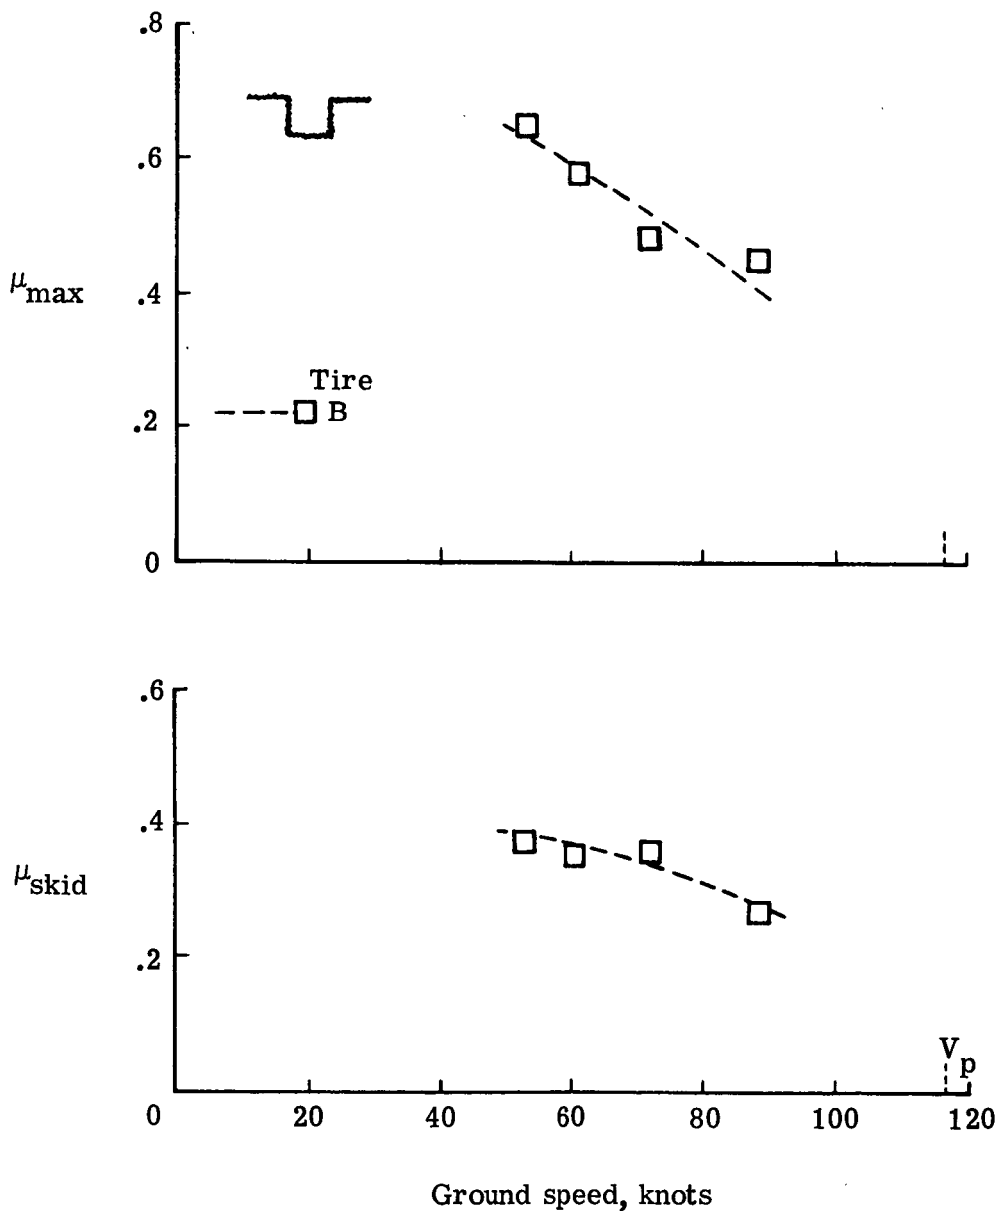
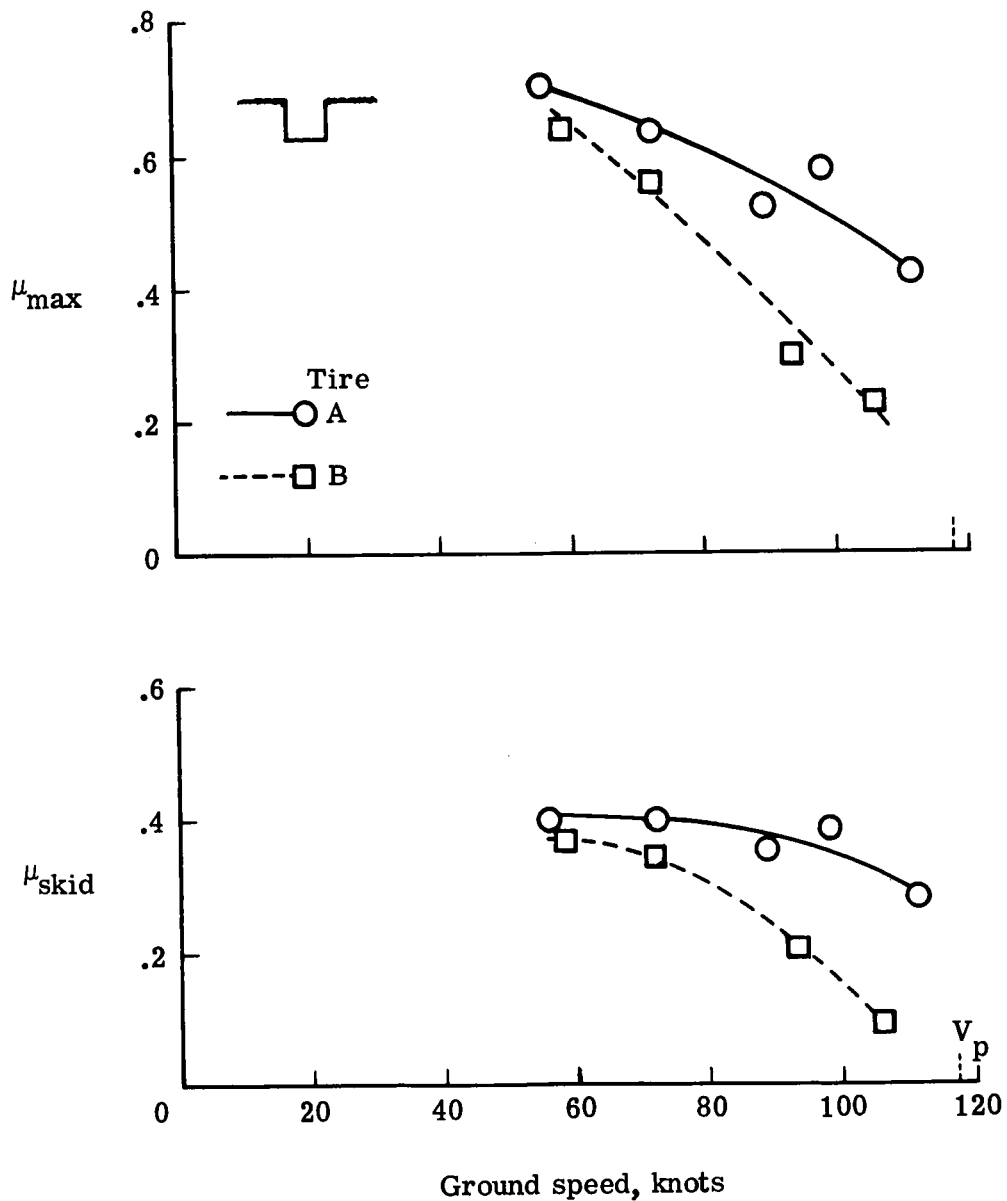
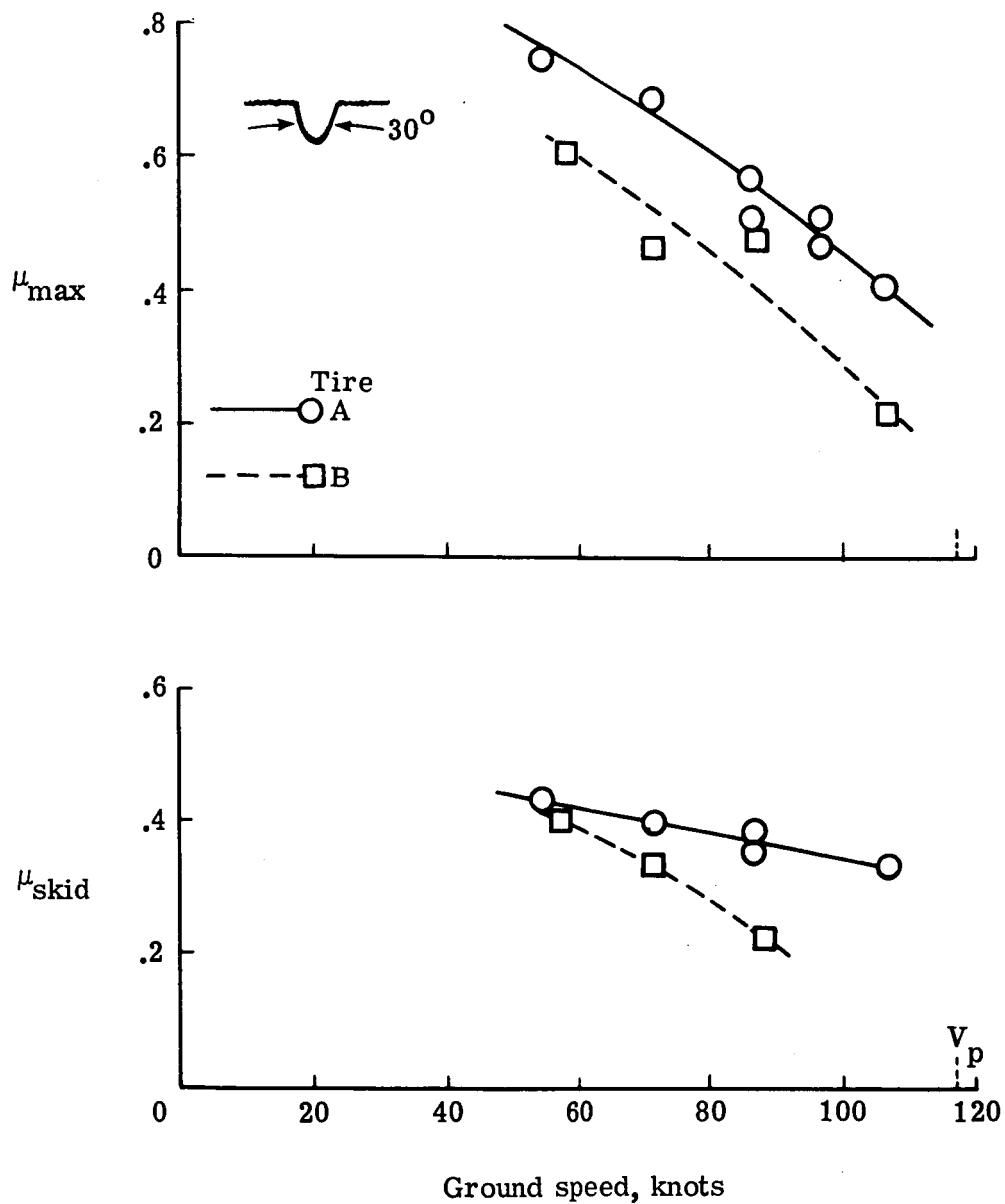
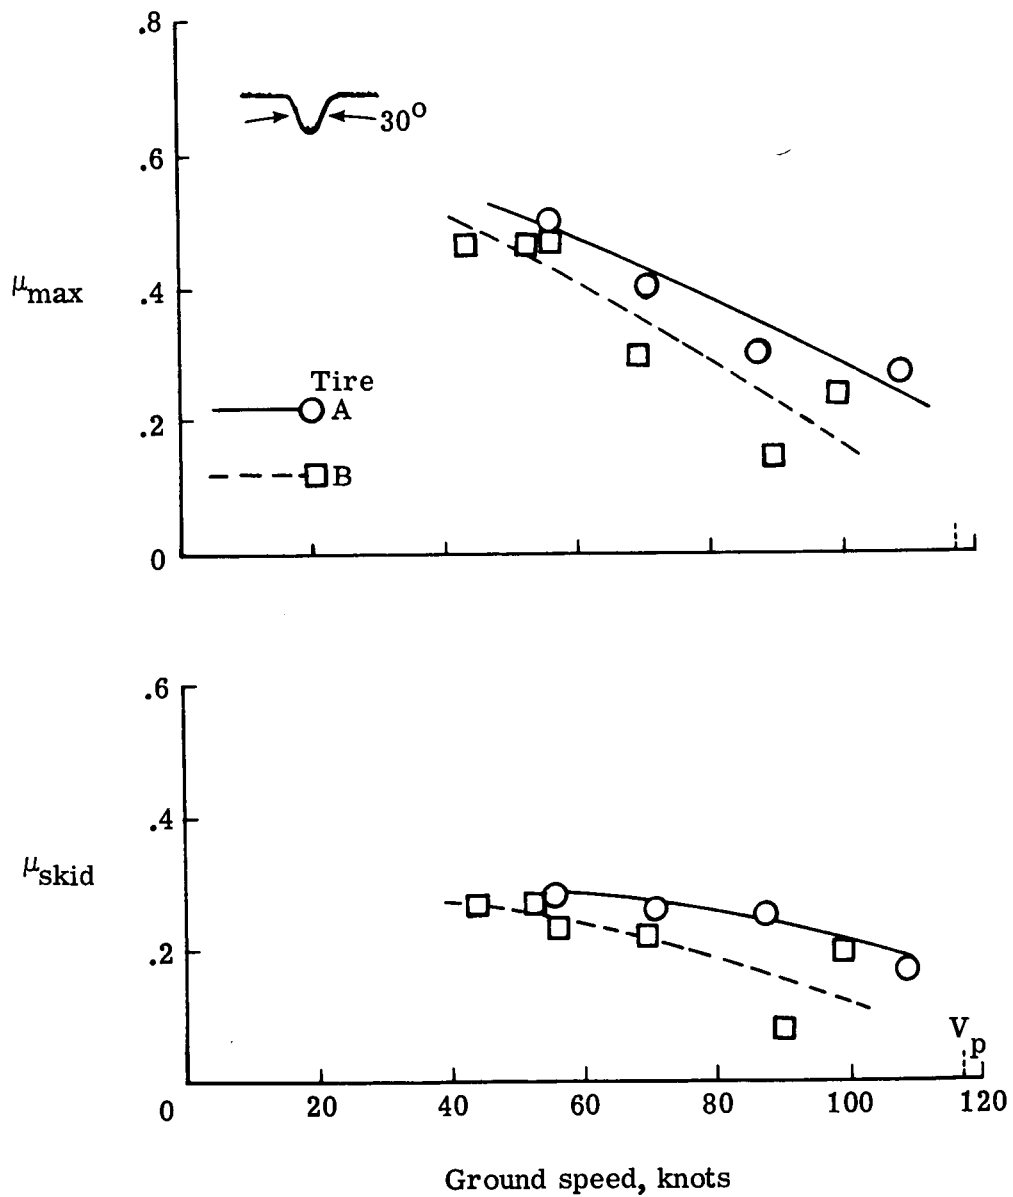
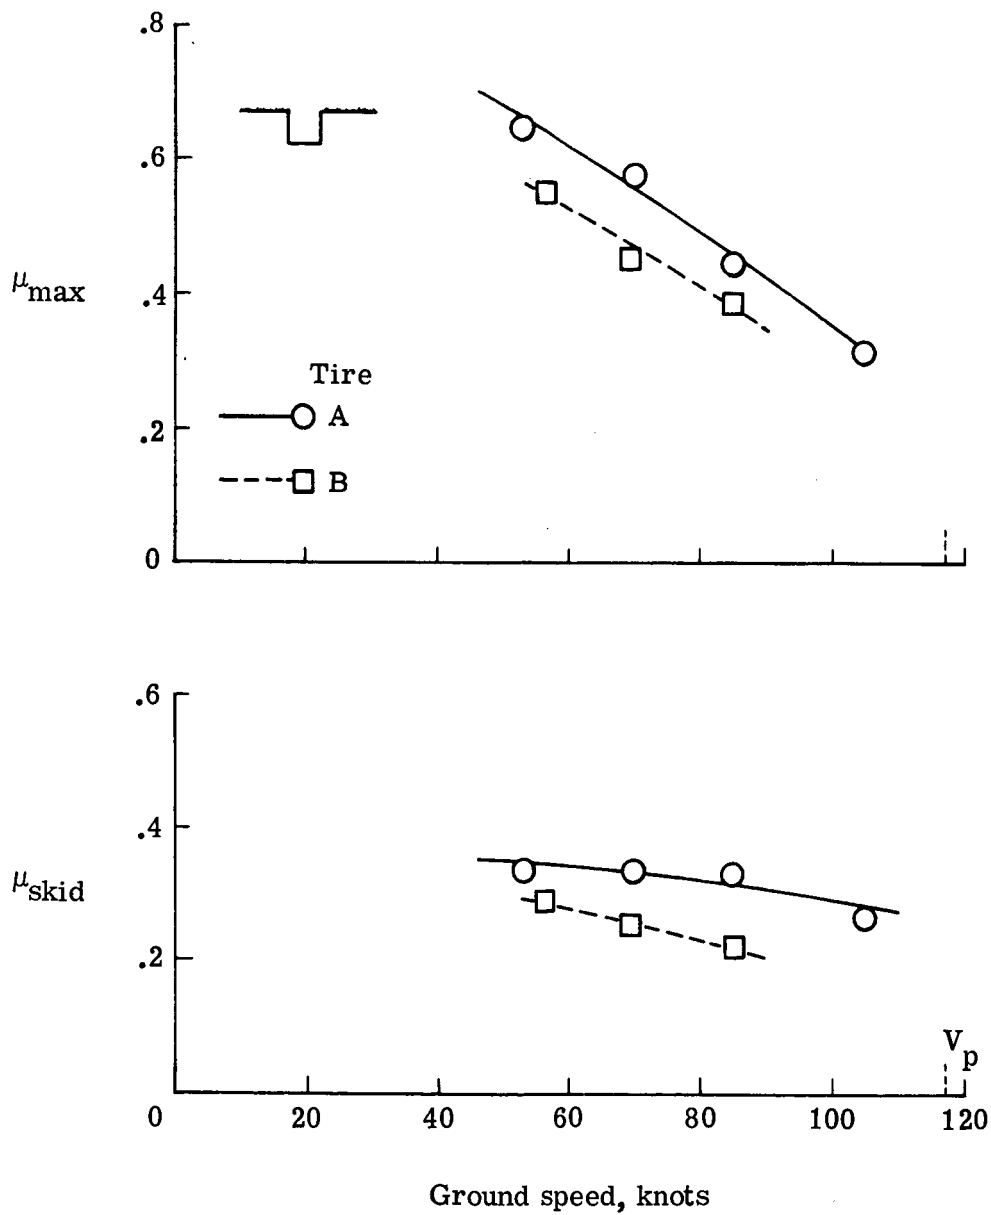
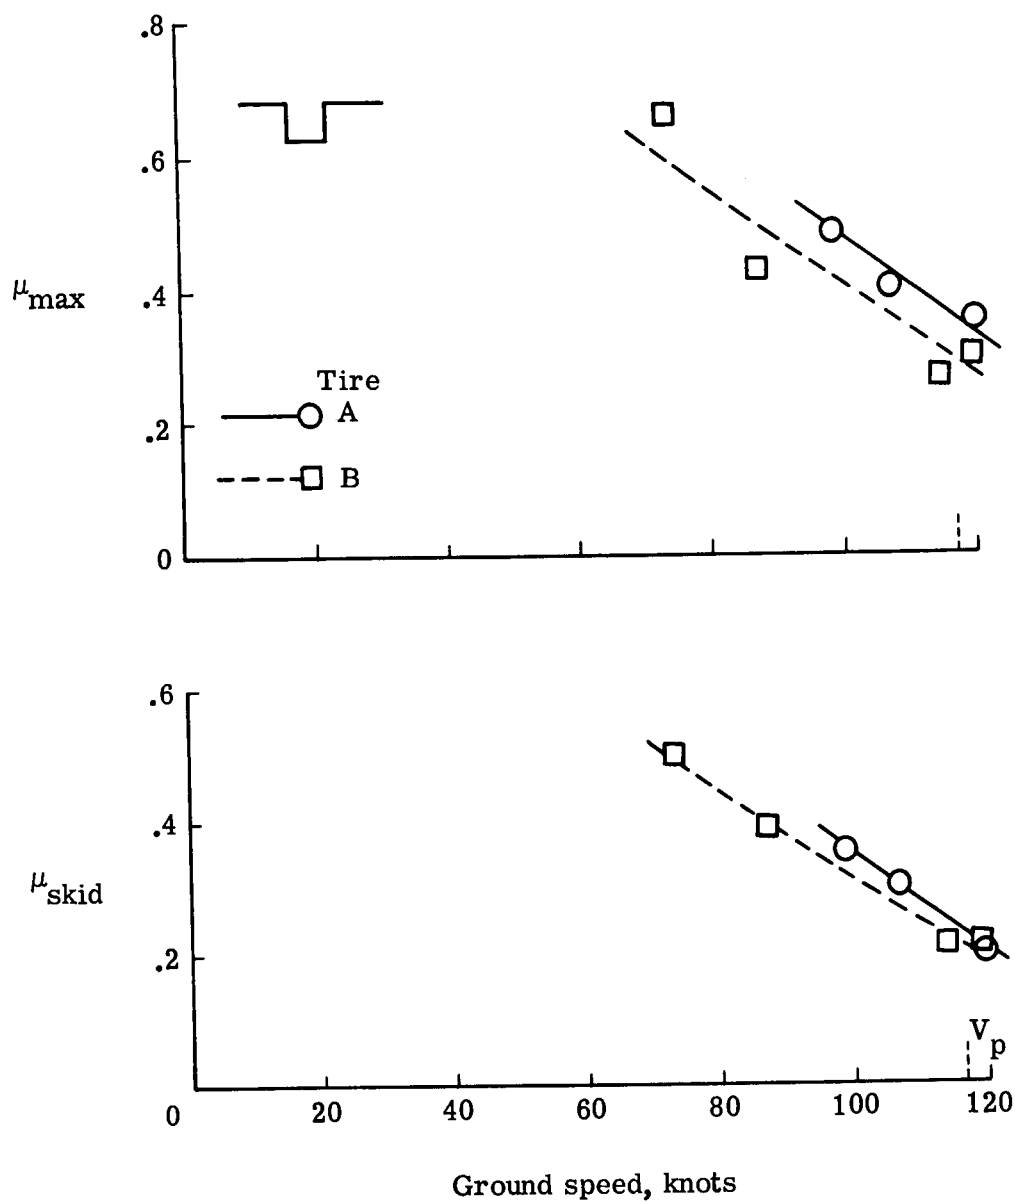
(a) Surface 1 (ungrooved).

Figure 5.- Summary of braking traction results on different test surfaces under flooded conditions.

(b) Surface 2 (combed); 1.9 cm by 0.3 cm by 0.3 cm
(3/4 in. by 1/8 in. by 1/8 in.); rectangular.

(c) Surface 3 (combed); 3.2 cm by 0.6 cm by 0.6 cm ($1\frac{1}{4}$ in. by $\frac{1}{4}$ in. by $\frac{1}{4}$ in.); rectangular. Data not obtained for tire A.

(d) Surface 4 (sawed); 3.2 cm by 0.6 cm by 0.6 cm
 ($1\frac{1}{4}$ in. by $\frac{1}{4}$ in. by $\frac{1}{4}$ in.); rectangular.

(e) Surface 5 (sawed); 3.2 cm by 0.6 cm by 0.6 cm
 ($1\frac{1}{4}$ in. by $\frac{1}{4}$ in. by $\frac{1}{4}$ in.); V-rounded bottom.

(f) Surface 6 (sawed); 3.2 cm by 0.6 cm by 0.6 cm ($1\frac{1}{4}$ in. by $\frac{1}{4}$ in. by $\frac{1}{4}$ in.); V-rounded edge and bottom.

(g) Surface 7 (sawed); 3.2 cm by 0.5 cm by 0.5 cm
 ($1\frac{1}{4}$ in. by $\frac{3}{16}$ in. by $\frac{3}{16}$ in.); rectangular.

(h) Surface 8 (sawed); 2.5 cm by 0.6 cm by 0.6 cm
(1 in. by 1/4 in. by 1/4 in.); rectangular.

The instantaneous maximum drag-force friction coefficient μ_{\max} and the steady-state, locked-wheel, drag-force friction coefficient μ_{skid} were computed from histories of the vertical loading and drag loading measured at the wheel axle during braking runs. The values of μ_{skid} represented the average of those measured over the approximate 3.05 meters (10 ft) skidding distance. The variation of μ_{\max} and μ_{skid} with ground speed is used as a basis of comparison in evaluating the braking performance of different test tire and surface combinations. Figure 5 summarizes the results obtained with the two tires on each of the test surfaces (surfaces 1 to 8). The curves faired through these

The data of figure 5 generally show a significant reduction in traction with an increase in ground speed for both tires on all test surfaces. The computed dynamic hydroplaning speed for these tires, based upon an inflation pressure of 117 N/cm^2 (170 lb/in^2), is 117 knots. (See ref. 9.) On the ungrooved surface (surface 1), both the maximum and skidding friction coefficients decrease to negligible values as the hydroplaning speed is approached. However, on the grooved surfaces, the ground speed at which the friction levels approach zero appears, in general, to be somewhat greater than the hydroplaning speed. This delay in dynamic hydroplaning may be attributed to the higher bearing pressures in the tire footprint which result from the reduced contact area provided by the grooving configurations combined with improved water drainage and possible mechanical interlock between the tire tread and the grooved surface. (See refs. 3, 10, and 11.)

Some effects of tire tread design on traction can be established from the data of figure 5. Data are presented for both test tires on each surface except for surface 3 where no data were obtained with tire A. Tires A and B were observed in reference 7 to be, respectively, the most and least susceptible to chevron cutting tread damage of the four tires tested and, as a result, were selected as the test tires in this program. The figure shows that tire A generally developed the higher value of μ_{\max} and μ_{skid} , the difference in friction levels between the two tires being greater on some surfaces than on others. This difference is attributed to the higher net bearing pressure associated with tire A (145 N/cm^2 (210 lb/in^2)) as compared with tire B (107 N/cm^2 (155 lb/in^2)). The tread groove area in the static footprint of tire A is nearly three times that of tire B (see fig. 3) which would alleviate dynamic hydroplaning effects and improve traction by increasing water drainage from the tire-ground contact zone.

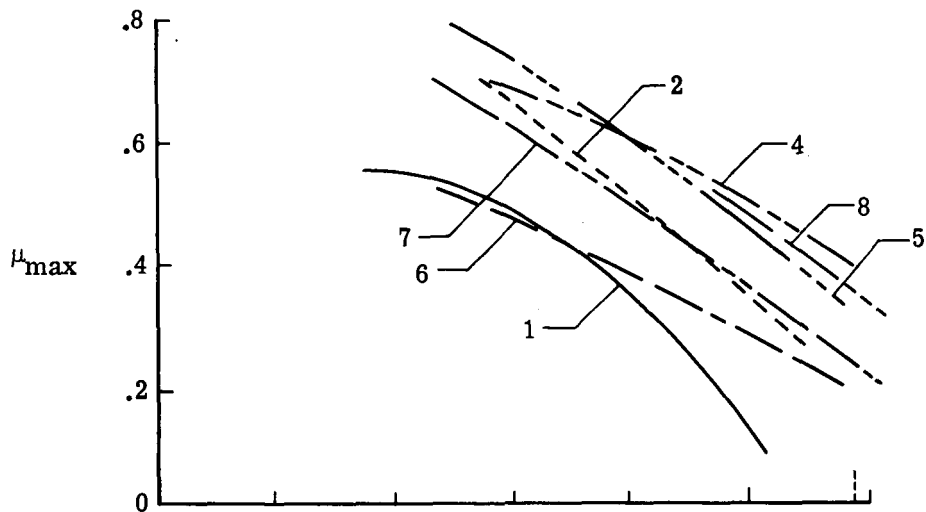
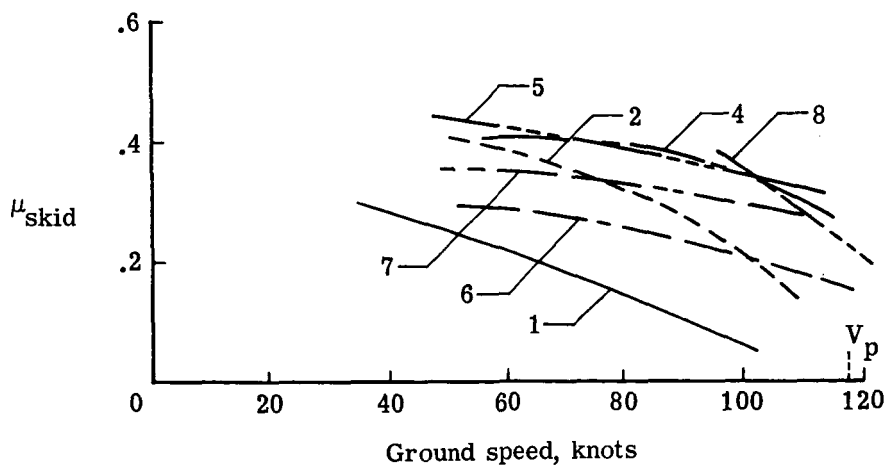
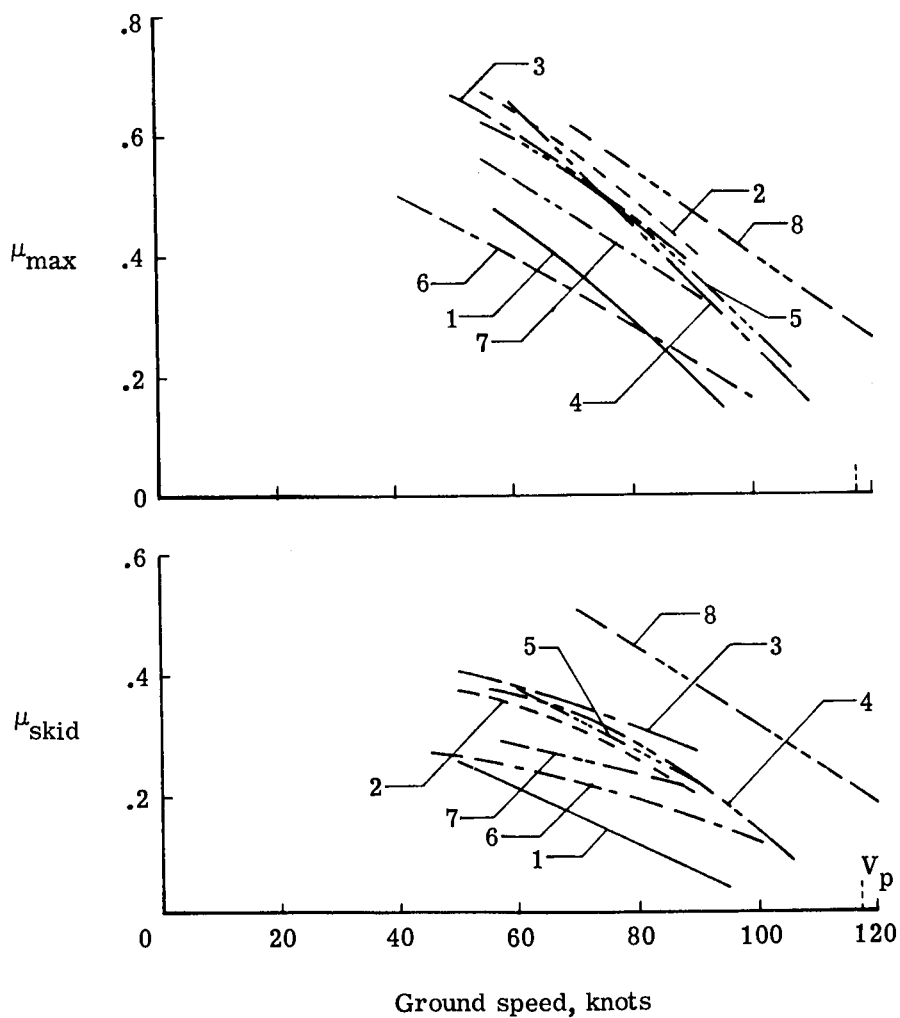
(a) Tire A.

Figure 6.- Effect of runway groove patterns on flooded braking traction.

(b) Tire B.

data are repeated in figure 6 to provide a ready comparison of the braking traction afforded by the different groove configurations.

The effect of runway groove configuration on the friction coefficients developed by both tires are summarized in figure 6 for all test surfaces. The figure shows that the friction coefficients developed on the grooved surfaces were higher than those developed on the ungrooved surface at corresponding ground speeds except for values of μ_{max} developed on surface 6 at the lower speeds. The low friction measured on surface 6, a modified V-groove configuration, is attributed to the polished lands and the rounded groove edges of this particular surface. The data of figure 6 show that with tire A, surfaces 4, 5, and 8 provided comparable flooded traction at a level slightly greater than that provided by the other grooved surfaces and, with tire B, surface 8 is shown to provide the best traction. The data suggest that tire braking capability under wet conditions increases as the total cross-sectional area of the pavement grooves in the tire footprint increases (or as the tire-to-surface contact area decreases). Of the groove configurations investigated, that of surface 8 (2.5 cm by 0.6 cm by 0.6 cm or 1 in. by 1/4 in. 1/4 in.) provided the greatest groove cross-sectional area and, in general, offered the best traction under flooded conditions. The groove configuration of surface 8 is the same configuration which was determined to be the best of 18 configurations evaluated during an earlier tire braking study conducted in 1967. The data of that study, reported in reference 10, were obtained from a smooth tread, size 27.5×7.5 , type VIII, aircraft tire inflated to 275 N/cm^2 (400 lb/in^2) undergoing locked-wheel skids at ground speeds up to 100 knots.

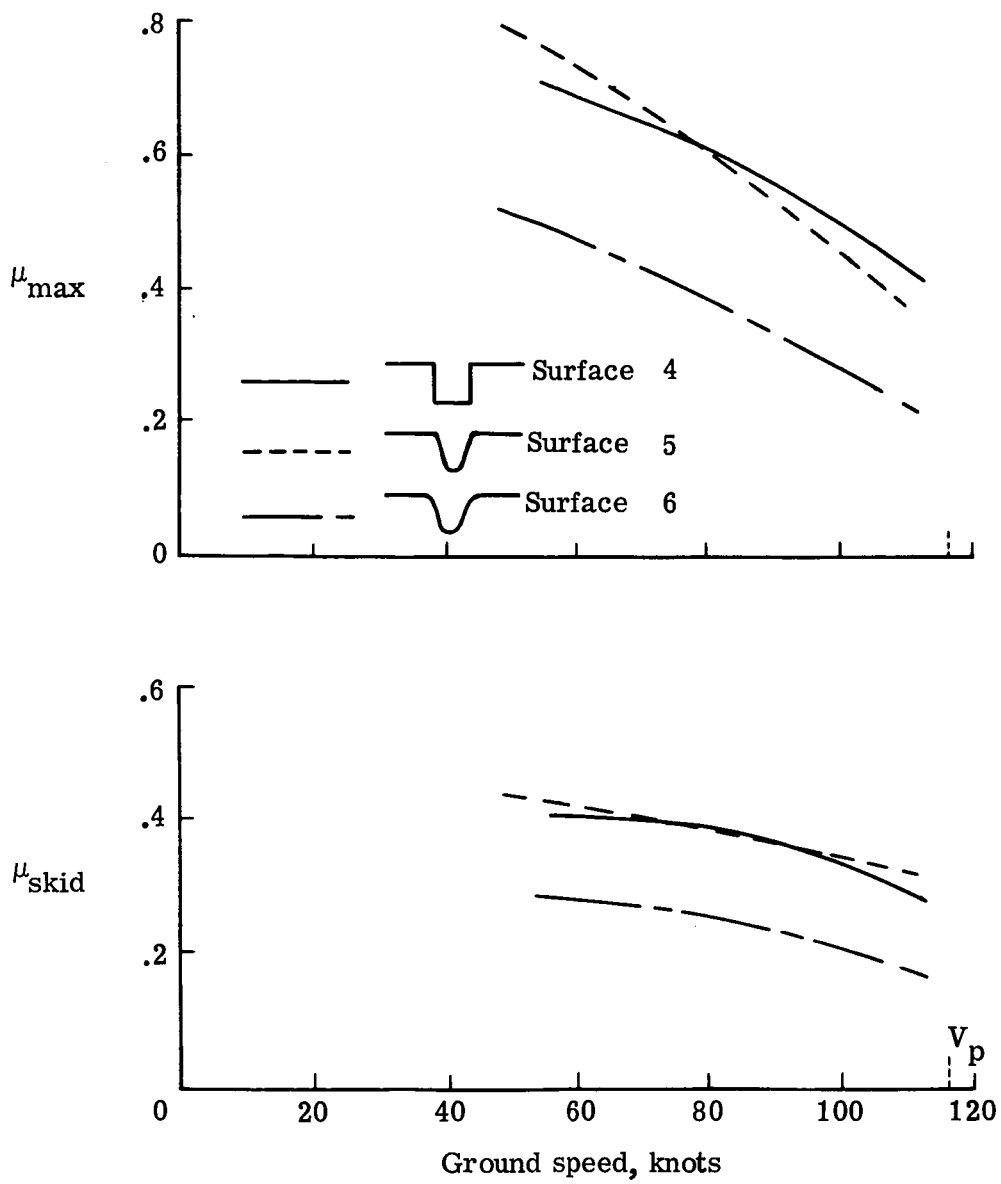
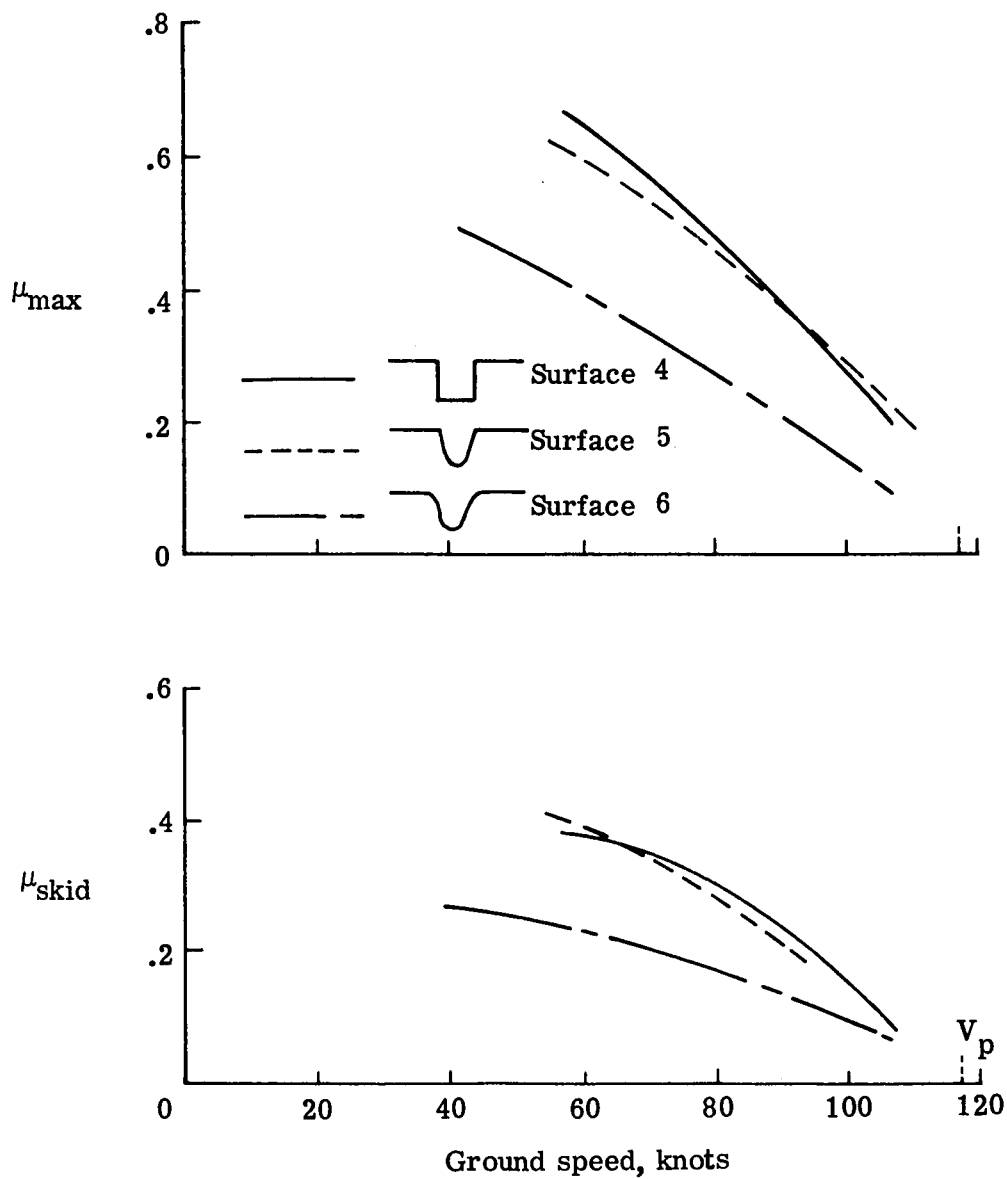
(a) Tire A.

Figure 7.- Effect of groove shape on braking traction.

(b) Tire B.

An effect of pavement groove shape is indicated in figure 7 by the braking traction levels developed with both test tires on three grooved configurations (surfaces 4, 5, and 6) with similar groove dimensions. Surface 4 has a rectangular groove shape with sharp

edges, surface 5 has rounded groove edges on the bottom with sharp edges on the top, and surface 6 has rounded groove edges at both top and bottom. No significant difference in the traction levels is noted between surface 4 and surface 5; however, there is a significant reduction in traction on surface 6 that is attributed to the rounded groove edges and to the inadvertently polished lands between the grooves. It should also be pointed out that rounding the groove edges tends to reduce the susceptibility of the tire tread to chevron cutting damage at touchdown. (See ref. 7.)
